NABCO ENTRANCES TECHNICAL BULLETIN

Relocation of Motor Fuse on GT300/400/500/8300/8400/8500 Swing Operators with Magnum-4 Controls

Bulletin Number: 46

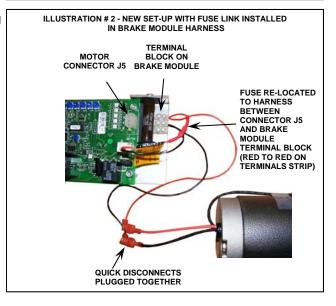
In some instances the in-line motor protector fuse link located on the motor wires of a Gyro Tech swing operator can blow resulting in the door closing fast without electronic braking. With the fuse blown, braking is disabled even when the door is used manually. A picture of the inline motor protector fuse is shown in Illustration # 1 below. The cause appears to be related to activation of the door while it is locked or in some way prevented from opening. Lowering the settings for door opening speed, and increasing the Recycle sensitivity (by adjusting the current limit potentiometer counter clockwise) will help prevent fuse failure.

Refer to Illustration # 2 below. To resolve the issue of controlling a closing door in the event of a blown fuse, NABCO has relocated the fuse from the motor harness to the brake module harness. The harness plugs into motor connector J5 on the Magnum control. The other end of the harness connects to the terminal block on the brake module. The remaining quick disconnects on the motor harness can then be plugged together as shown in Illustration # 2. The brake module will now continue to control the door while closing even if the fuse blows. This change is already in effect on swing operators shipping from the factory. In the near future the fuse will be wired directly to the terminal block for ease of assembly and additional robustness.

To prevent the possibility of the loss of door braking on closing, NABCO strongly recommends removing the fuse from the motor wires on all existing installations after this date and replacing it with a retrofit harness to the brake module as shown below.
